47TH TURBOMACHINERY & 34TH PUMP SYMPOSIA
HOUSTON, TEXAS | SEPTEMBER 17-20, 2018
GEORGE R. BROWN CONVENTION CENTER

High Vibration Due to Steam Turbine Deposits

TURBOMACHINERY LABORATORY
TEXAS A&M ENGINEERING EXPERIMENT STATION

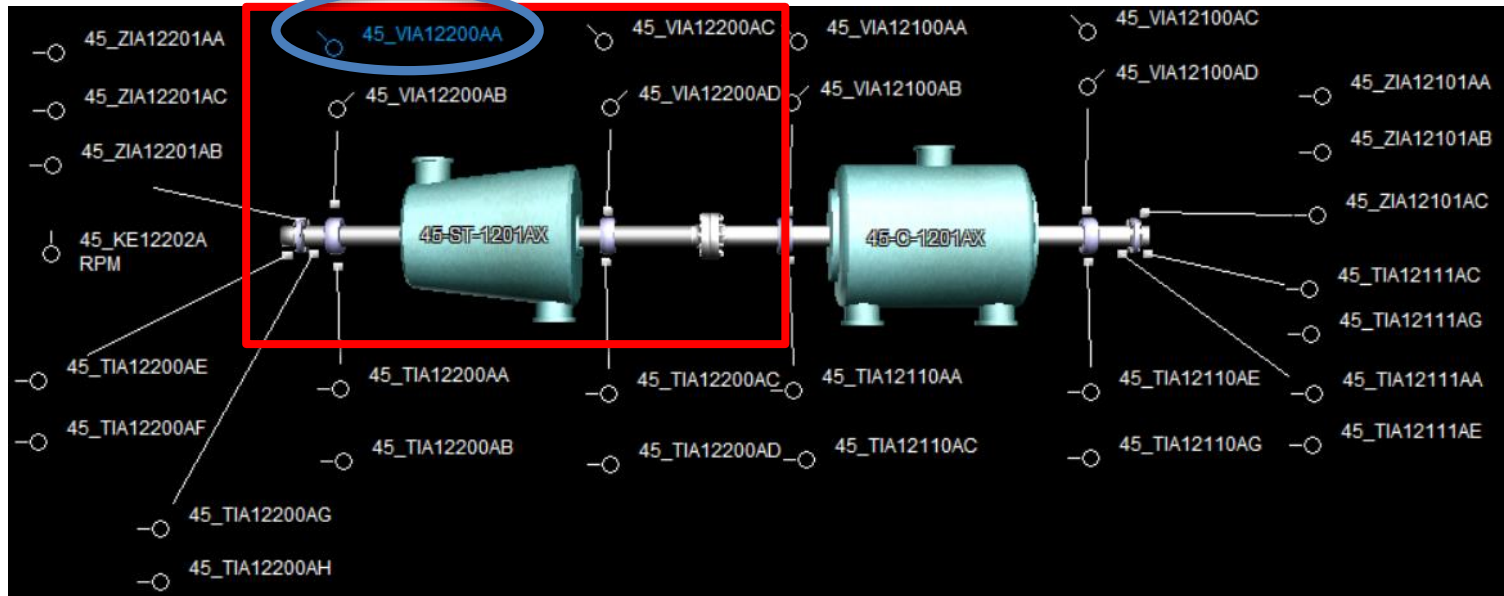
NDE Y-probe, 45° Left

After the machine had not run for a week without any work performed, vibration level on steam turbine bearings increased up to 5 times during its re-startup.

Before: 10 μm pp

After: 50 μm pp

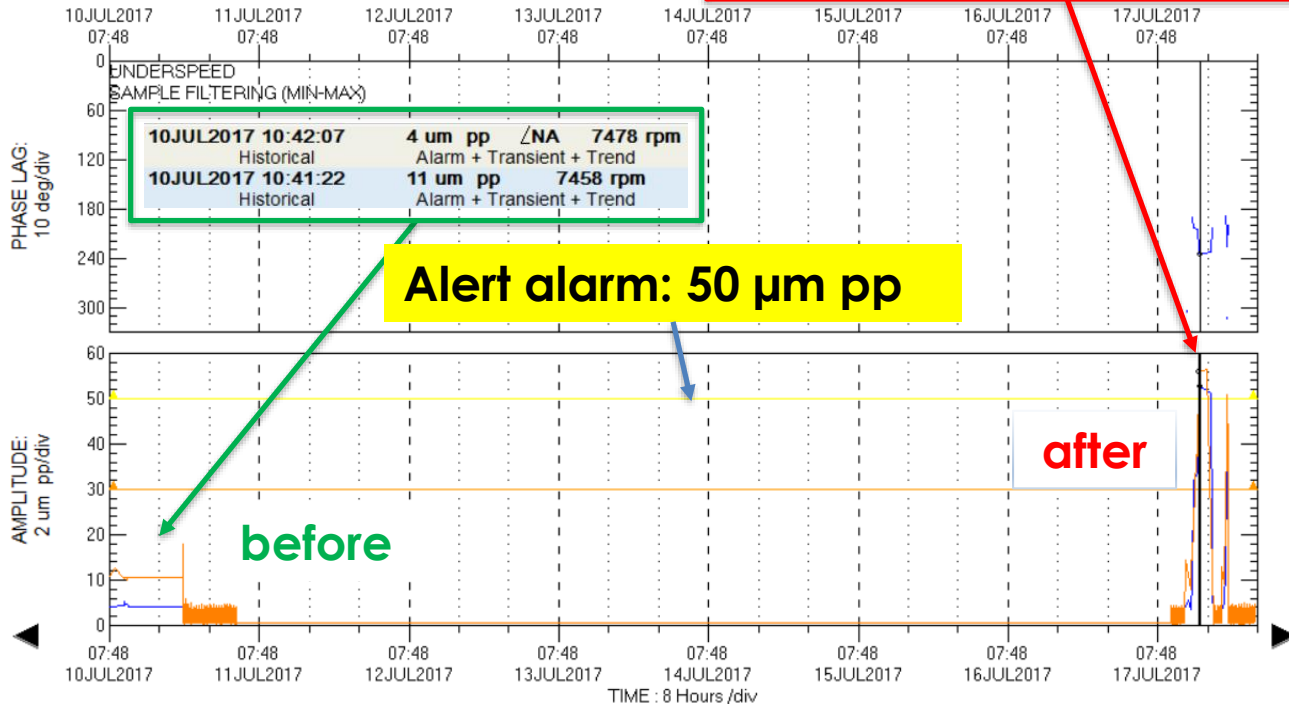
NDE Y-probe, 45° Left

- Before (July 10):
 - ~10 μm pp

- After (July 17):
 - 50+ μm pp
 - 1X dominant

High Vibration
due to 1X

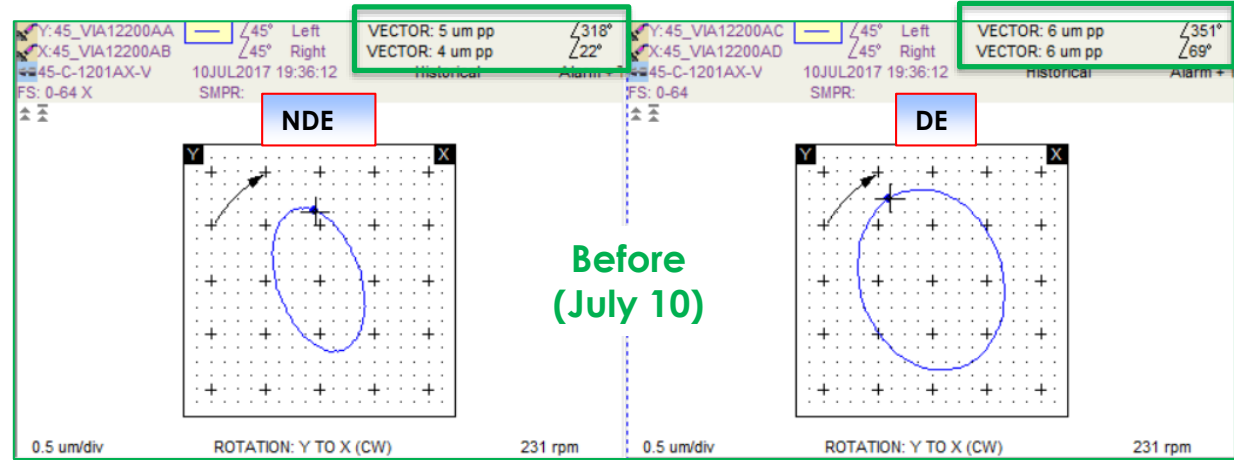
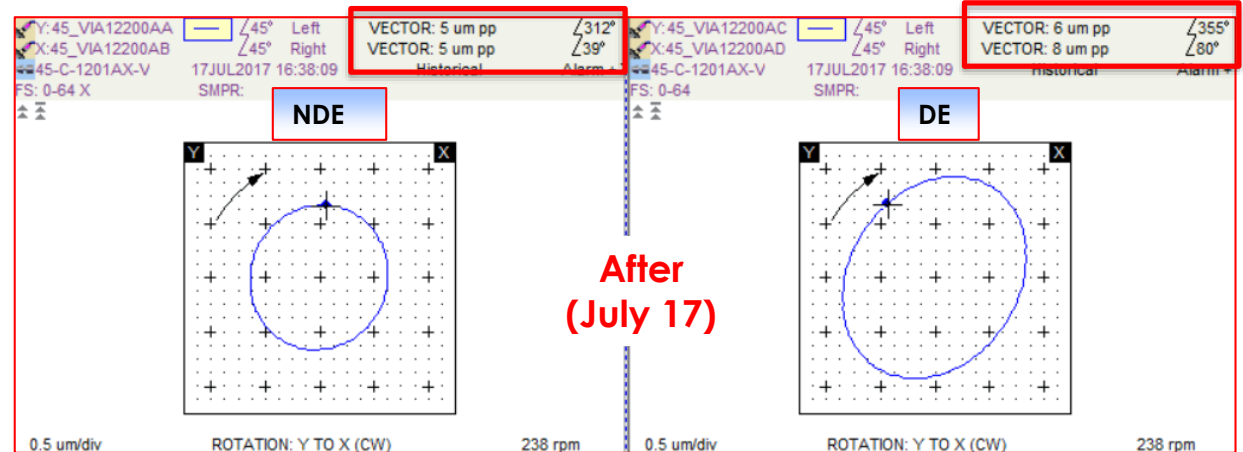
3.2 Data Review – 1X slow roll before & after

Same level of amplitudes with close phase angles

Not due to shaft bow

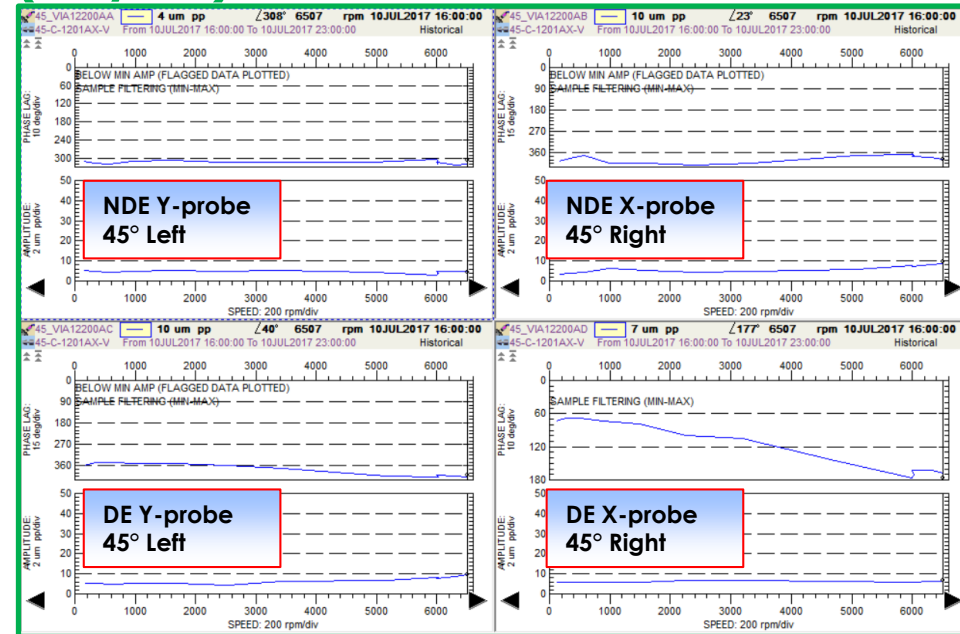
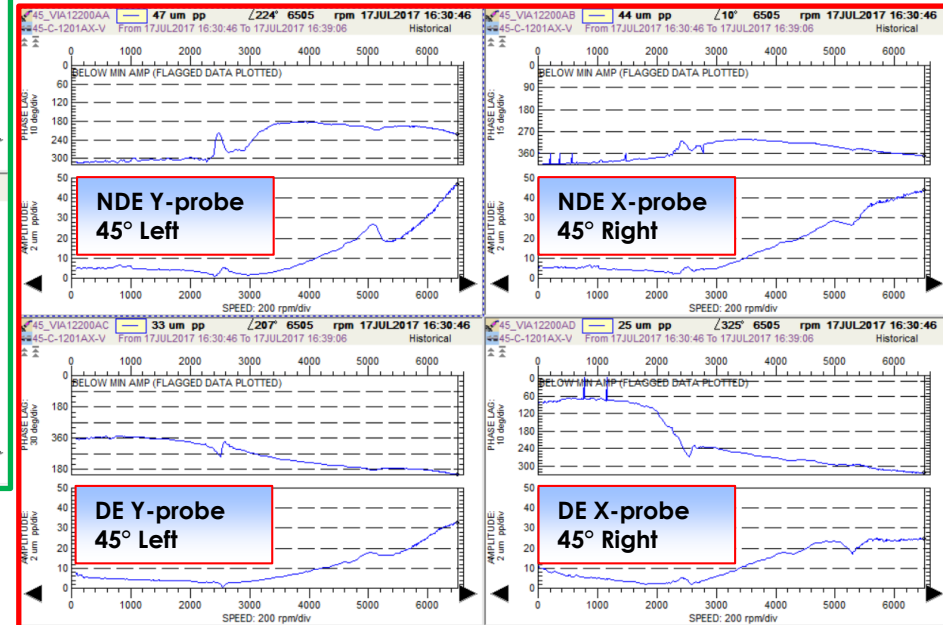
3.3 Data Review – 1X Bode plots before & after

Before : similar level as slow roll
(July 10) even at higher speed

**1X increasing
with speed**

After : Much higher than slow roll
(July 17) at higher speed

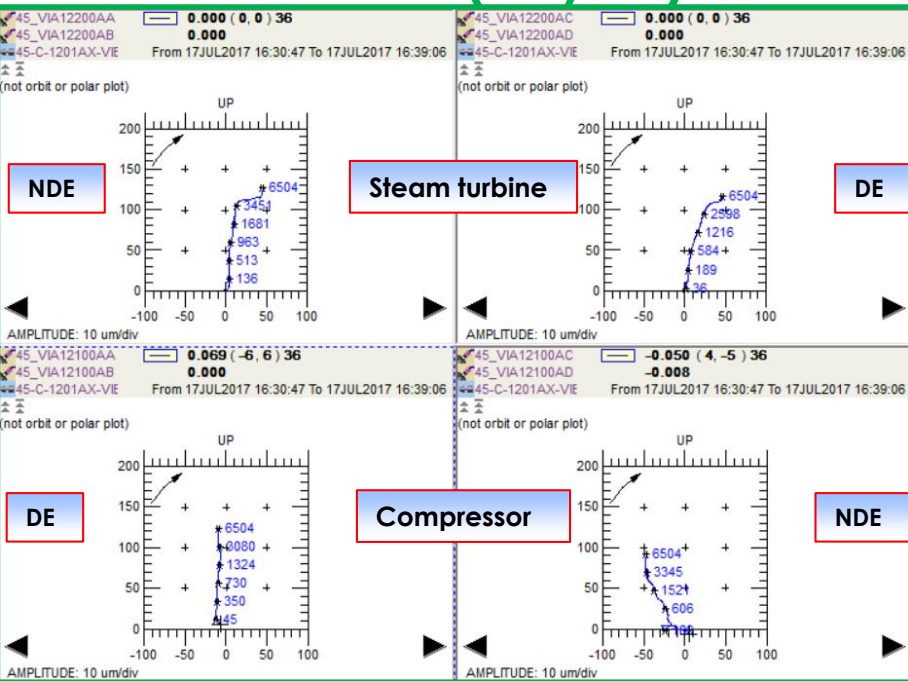
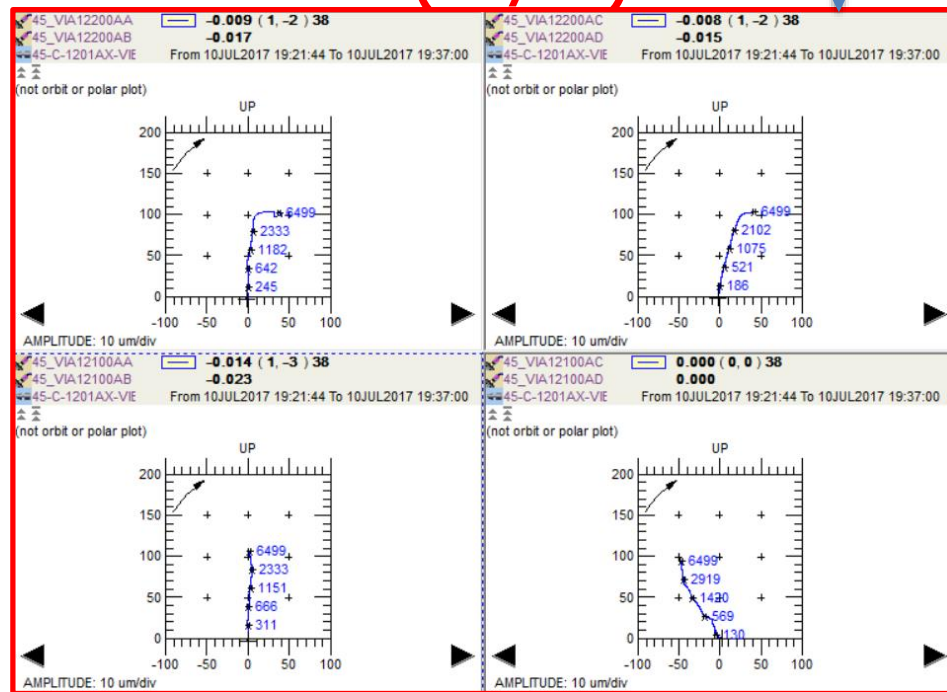
3.4 Data Review – Shaft centerline plots before & after

Almost identical

Not due to change in alignment

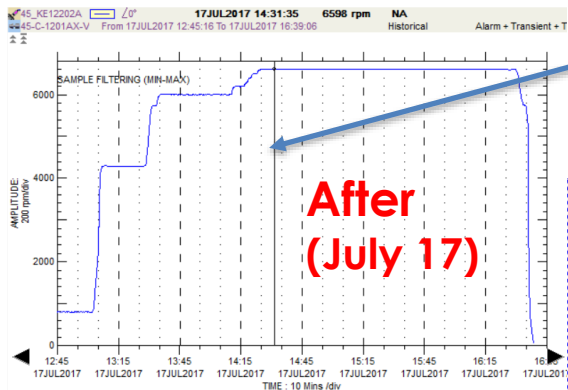
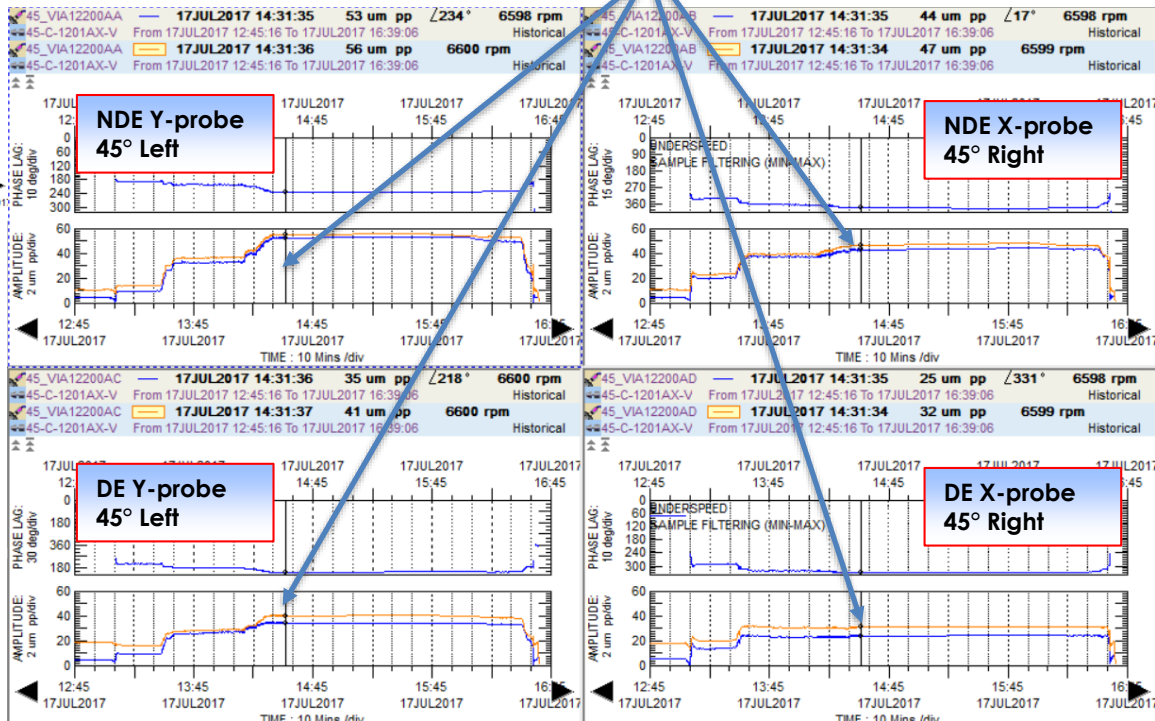
3.5 Data Review – Trend plots after re-startup

- Almost 1X
- Stable at constant speed

Not due to a rub

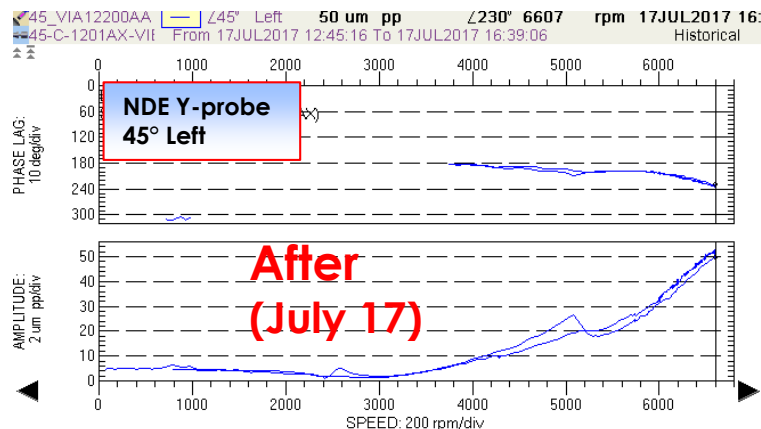
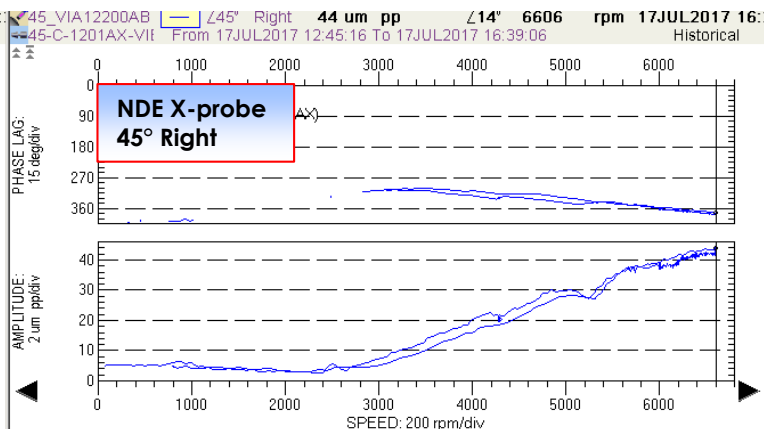
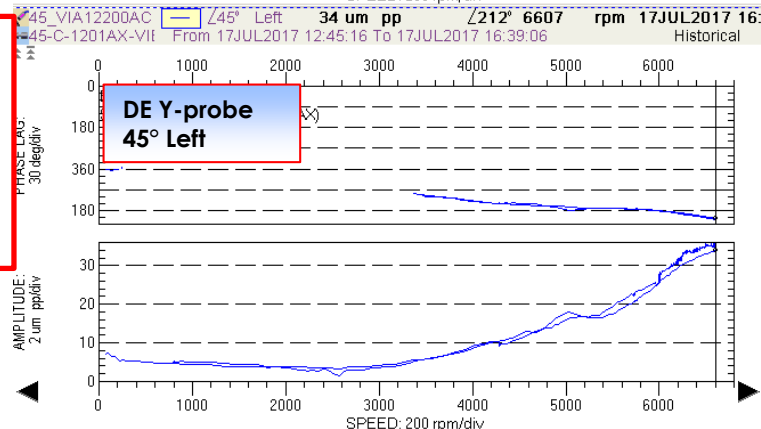
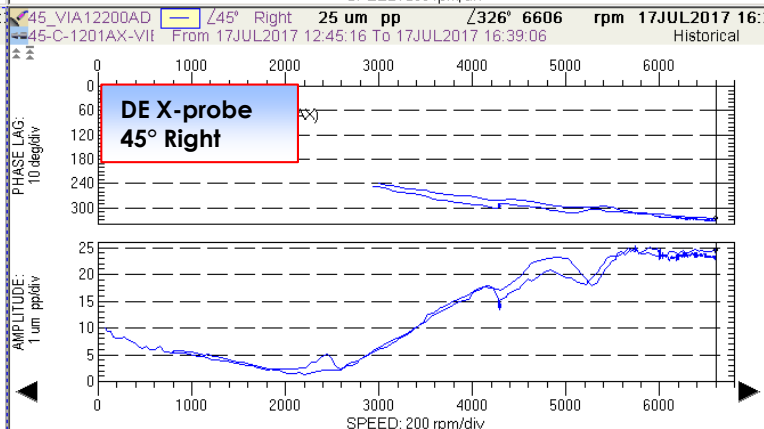
3.6 Data Review – Startup/shutdown Bode plots

Almost identical between startup & shutdown

Not due to a rub or shaft bow

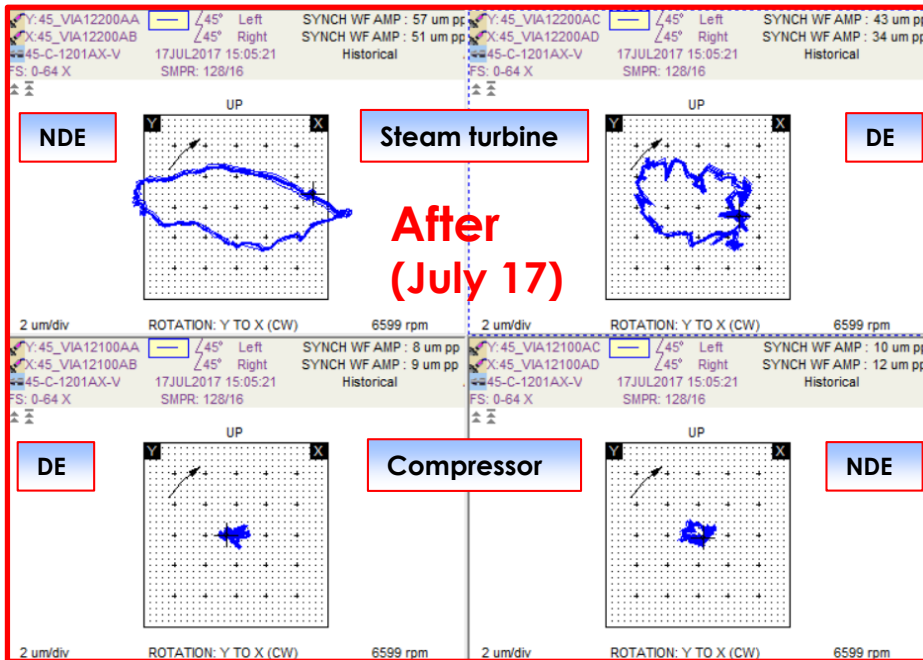
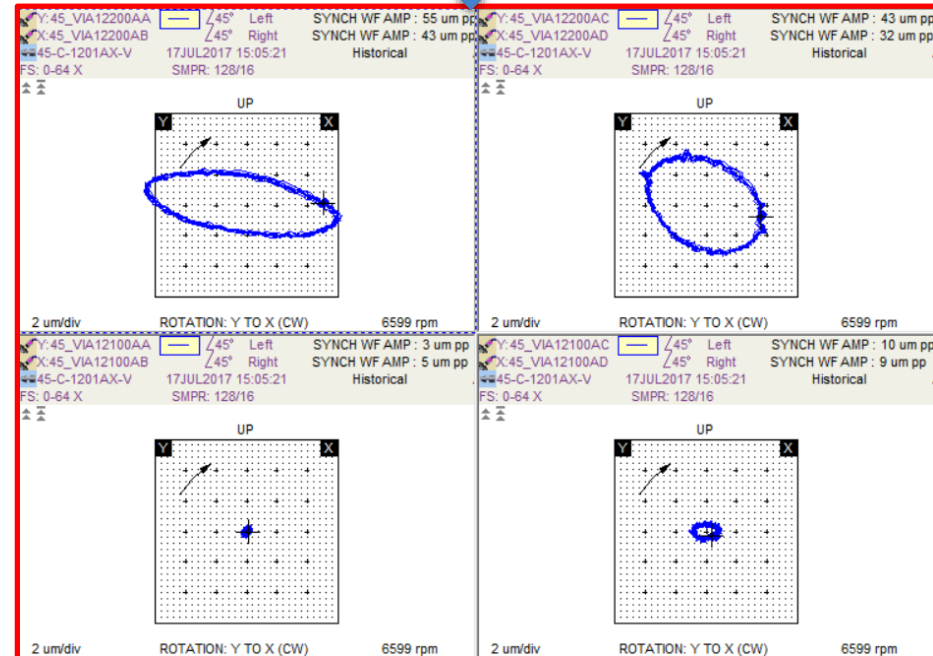
3.7 Data Review – Orbit plots at running speed

Smooth with waveform compensation

Normal orbits

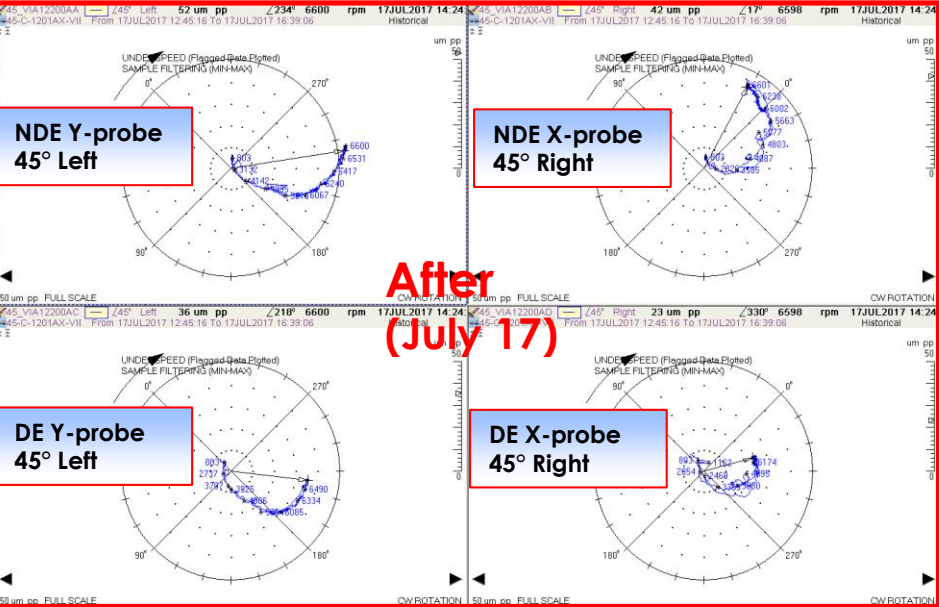
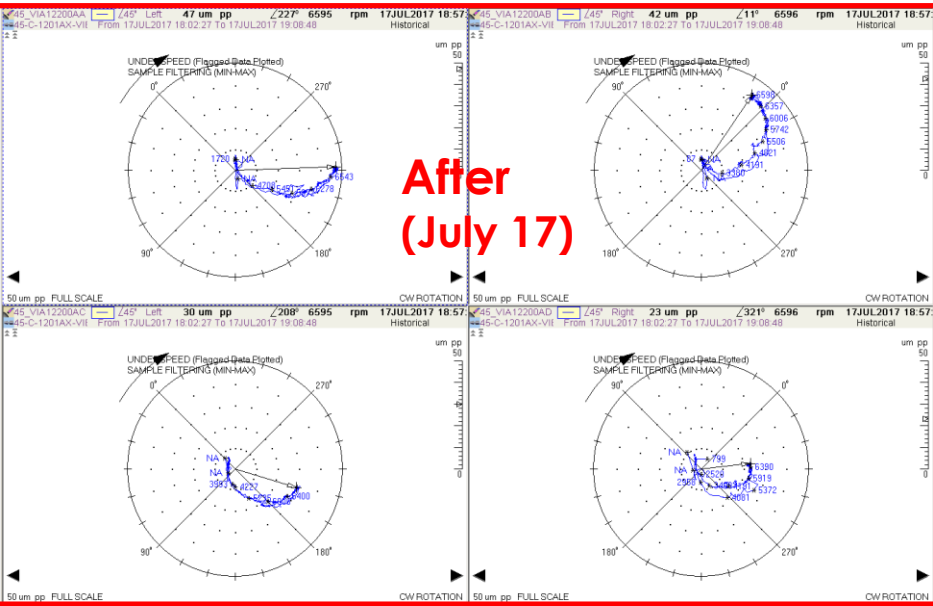
3.8 Data Review – Polar plots

Normal polar plots

Almost identical
between the two runs

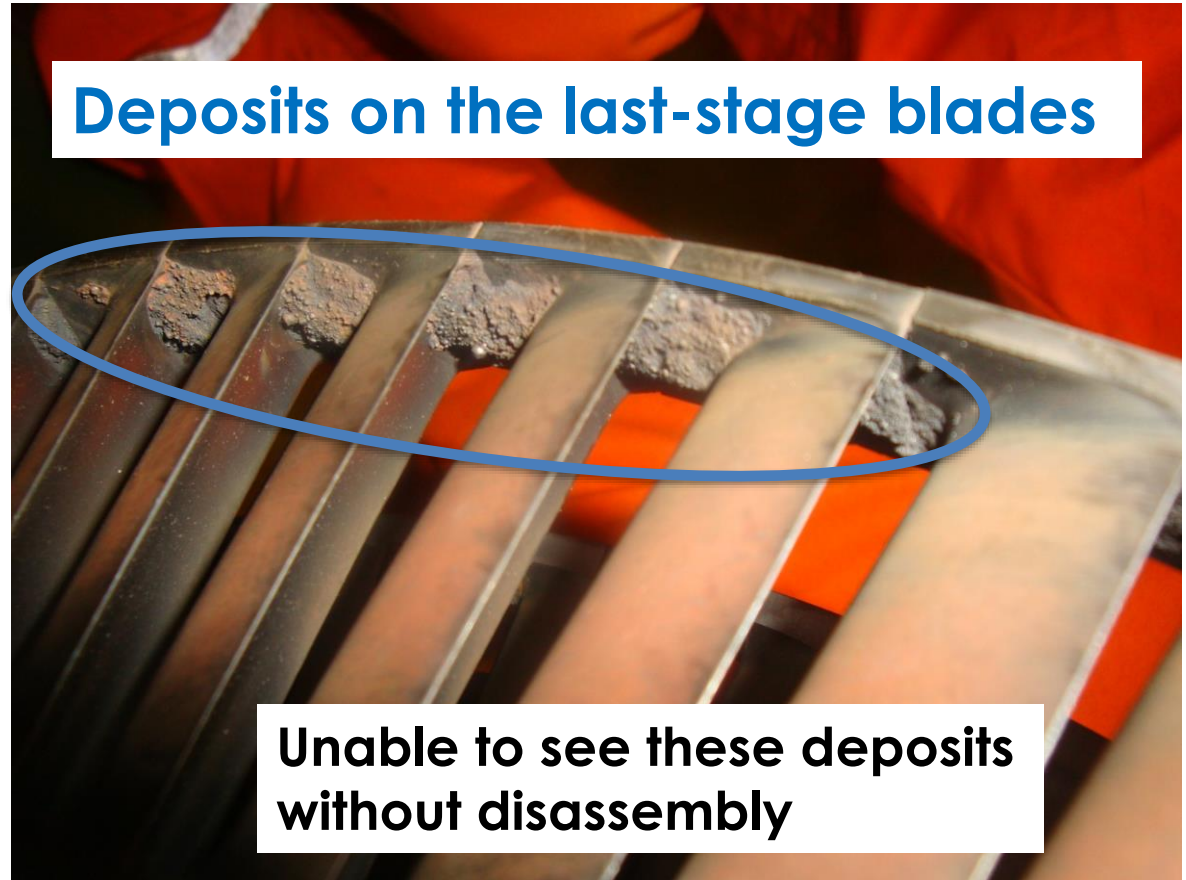
5.1 Inspection and Findings

- Large amounts of deposit at each stage found, from less to more in order from inlet to outlet.
- The coupling and shaft runout in good condition

- Such large amounts of deposit accumulated on turbine blades seems to be unusual.
- The 7-day non-running period could have created these deposits somewhere before entering to the turbine, unevenly accumulated on turbine blades.
- It was also possible that these deposits had been accumulated gradually and evenly for a long time. When the turbine was not running and became cold, some of deposits might have dropped during the initial turning, causing uneven distribution of deposits on turbine blades.

- To ensure safe and quick return of normal operation, the old rotor was replaced with a new one immediately after disassembly.
- To ensure no other issues besides the deposits, the old rotor was send to workshop for balance check and inspection as indicated before.

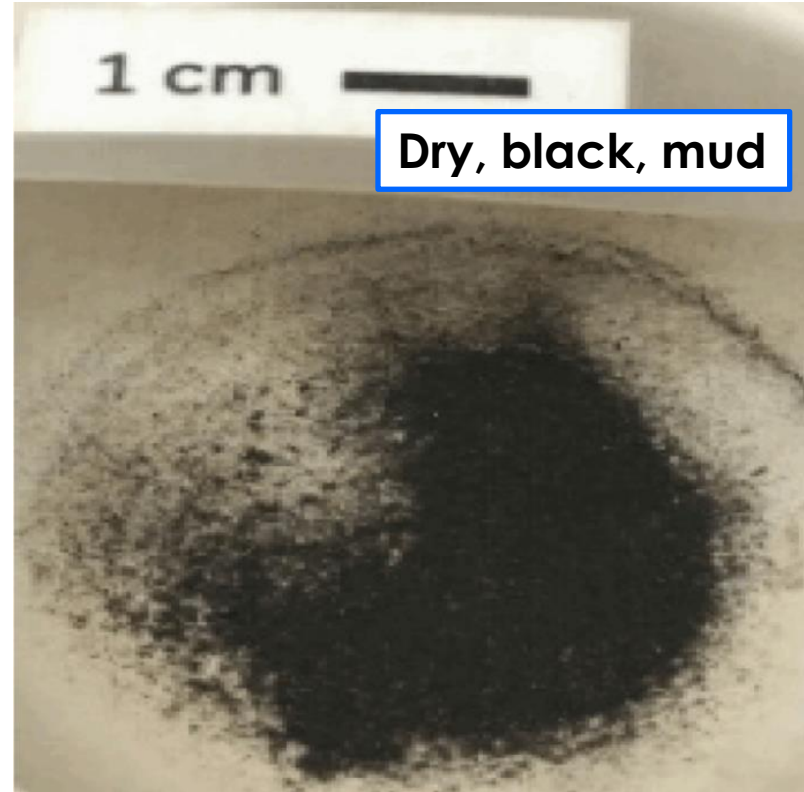
Photograph of the sample

- A sample of deposits analyzed, and its elements (checked from Sodium to Uranium) found to be mainly magnetite, or iron, Fe_3O_4 (90%).
- The deposits likely came from the boiler or some paths between the boiler and the turbine.

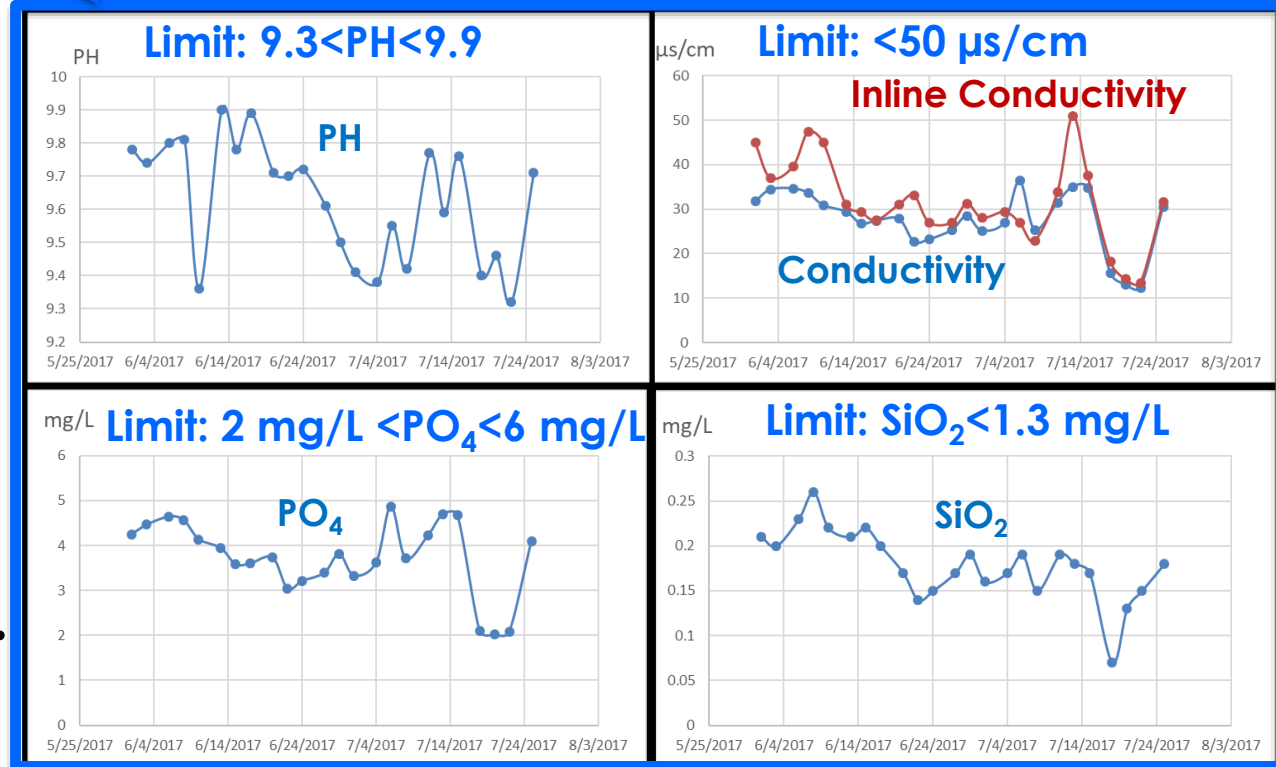
- **Boiler water quality** seemed normal around that period.
- Deaerator will be checked during next outage to examine any corrosion.
- The other sister unit will be inspected during shutdown as well.

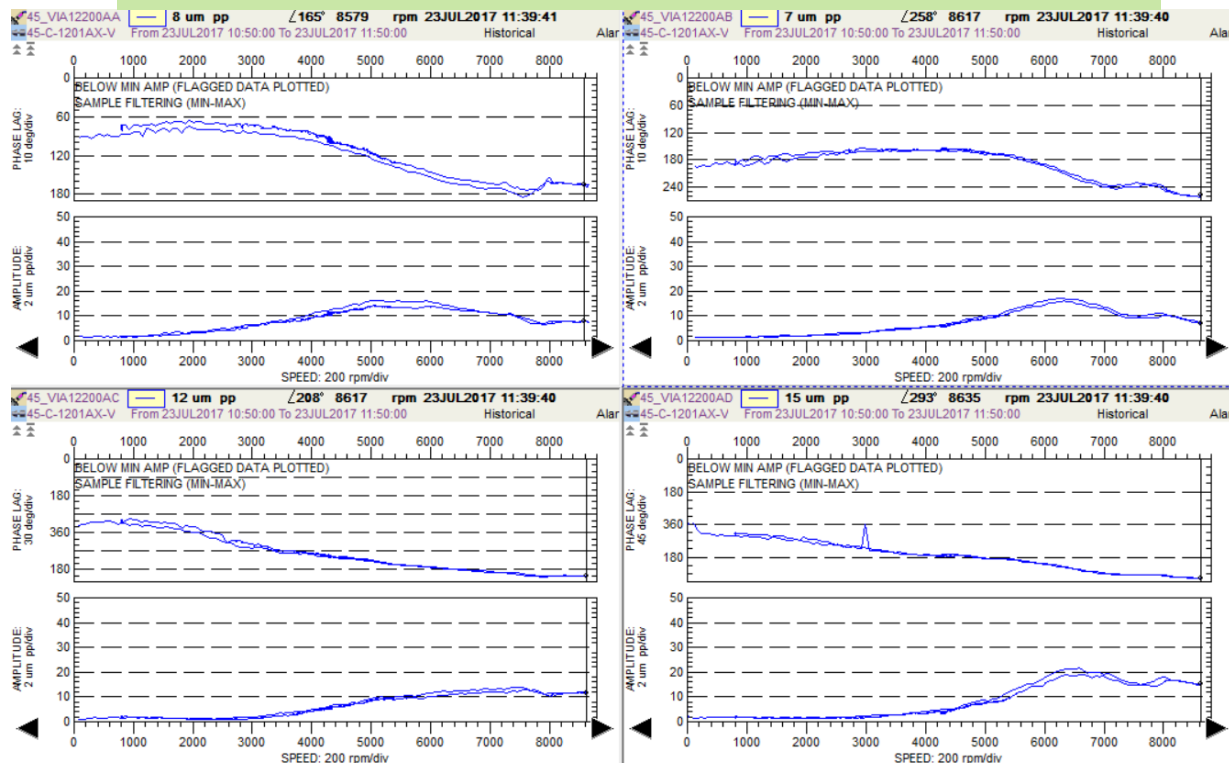
1X vibration on the new steam turbine rotor from 0 to 8600 rpm

1X vibration on the new steam turbine rotor below 20 μm pp at all speeds up to 8600 rpm,
